## HSS DAMAGE DUE TO WATER INFILTRATION AND FREEZING

by Kim Olson, PE  
Technical Consultant, Steel Tube  
Institute

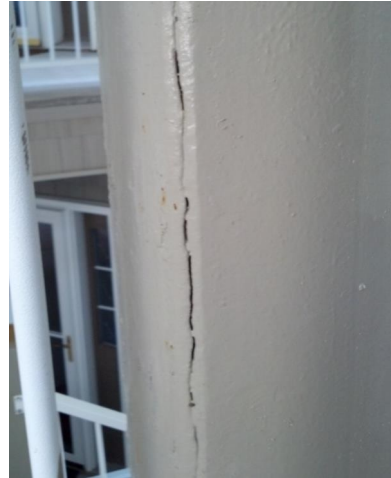
Often, for HSS exposed to weather, we specify a weld all around at the cap and base plates. Although this is a good start, this doesn't always mean the assembly is watertight. The continuous welding of the HSS seam and around the member at cap and base plates does not necessarily produce a complete, watertight seal. There is always the possibility of pin holes or micro-cracks in the member or at connections that may allow moisture to seep into the cavity of the HSS. Water can be drawn into the HSS by capillary action through these micro-openings when a relatively warm HSS is cooled by rainwater. If there is no path out for this water, it will remain in the cavity of the HSS, possibly building up over time, and then expanding under freezing temperatures. The HSS may not be able to restrain the bulging resulting from the ice.

If these preventive measures have not been followed at the forefront of a structure's life, it is possible that damage may occur as the moisture freezes and expands inside the cavity of the HSS member. Typically, a crack will propagate from a corner as this portion of the section is highly stressed from the forming process. The repair necessary depends on the loading of the member.

For that reason, STI recommends specifying a small weep hole at the base (or underside if a horizontal member) of the member, in addition to closing the section with cap and base plates. This small weep hole will allow any moisture that enters the section during construction or service to have a path out. If the member is galvanized, this weep hole can do double duty as a vent hole for the galvanizing process.

Before performing repairs, ensure that all water is removed from the HSS or a weep hole installed.

If the member is in pure compression, a structural repair is likely not necessary. The same amount of material is still present and continuity of the shape around the corners is not required for compression. It may be prudent to stop the propagation of the crack by gouging and then re-welding the crack.

If the member is used in bending (or compression and bending), gouging out the cracked area and then re-welding it back together, preferably using pre-heating, is one option. Then, it is usually a good idea to strengthen the area locally. For this, I have seen an angle fitted to the corner of the section and welded into place. If the crack is not at the corner, a cover plate can be added. This reinforcement will ensure that the member behaves as a closed section and the addition of more steel will locally enhance the cross-sectional properties.
