REPORT NUMBER: 101754207COQ-001
ORIGINAL ISSUE DATE: October 28, 2014

PRODUCT EVALUATED: Electrical Metallic Tubing and Metal-Clad Cables
EVALUATION PROPERTY: Impact and Crush Resistance

Report of Electrical Metallic Tubing and Metal-Clad Cables tested in accordance with selected sections of the standard as referenced below:

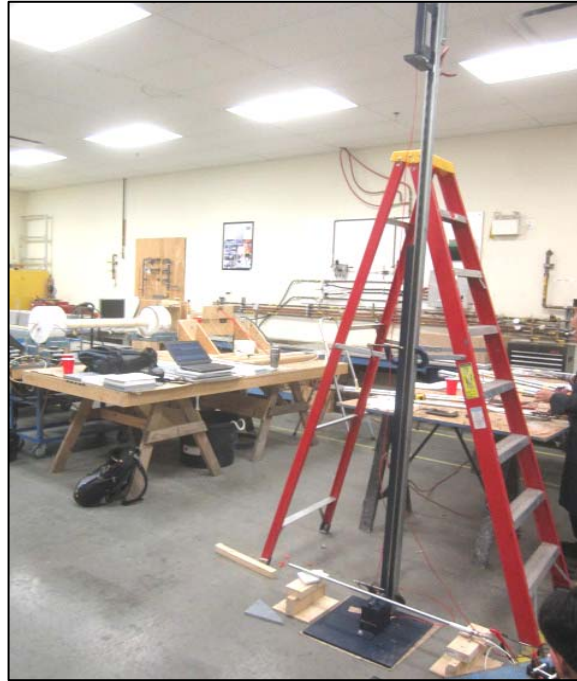
Figure 1. Impact Test Apparatus

samples were placed into an impact test apparatus and laid over a $\frac{3}{4}$ in. diameter steel rod as shown in Figures 1-2 below.

Each of the insulated circuit conductors in the length of EMT or MC Cable being tested were connected in series with a 3-W 120-V neon lamp to one of the energized conductors of a 208-V 48 – 62 Hz 4-wire grounded-wye a-c supply circuit. The bare or insulated grounding conductor in the test length of the tubing or cable was connected to the armor, to all parts of the impact apparatus, to earth ground, and to the grounded supply wire.

Each test sample was impacted at the center of each 3 ft. section using an impact weight of 10 lb. The impact weight was a solid rectangular block of steel with the impact face measuring 2 in. x 6 in. The impact weight was raised to the required drop height as specified by the client. A release mechanism allowed the impact weight to fall freely in the guides of the impact apparatus and strike the sample. Upon impact, the neon lamps were observed to see if they lit, indicating momentary or other contact between the circuit conductors or between one or both of the circuit conductors and the grounding conductor, the armor, or both. The maximum impact height was reported for three consecutive failures. Refer to Appendix B for after test photos of the test samples.

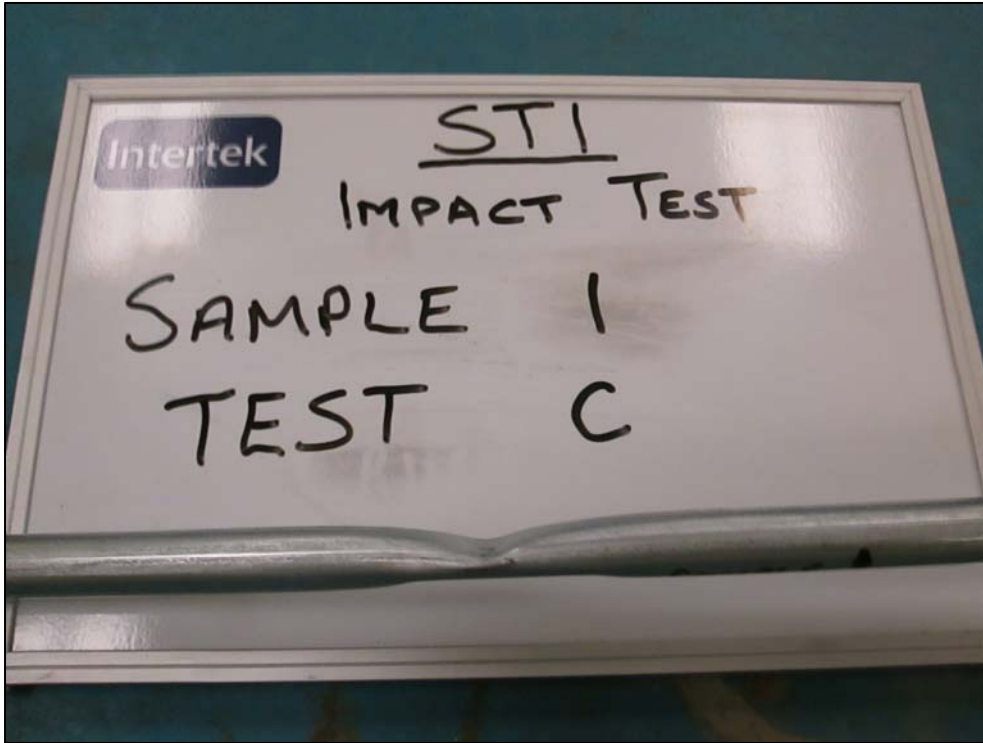
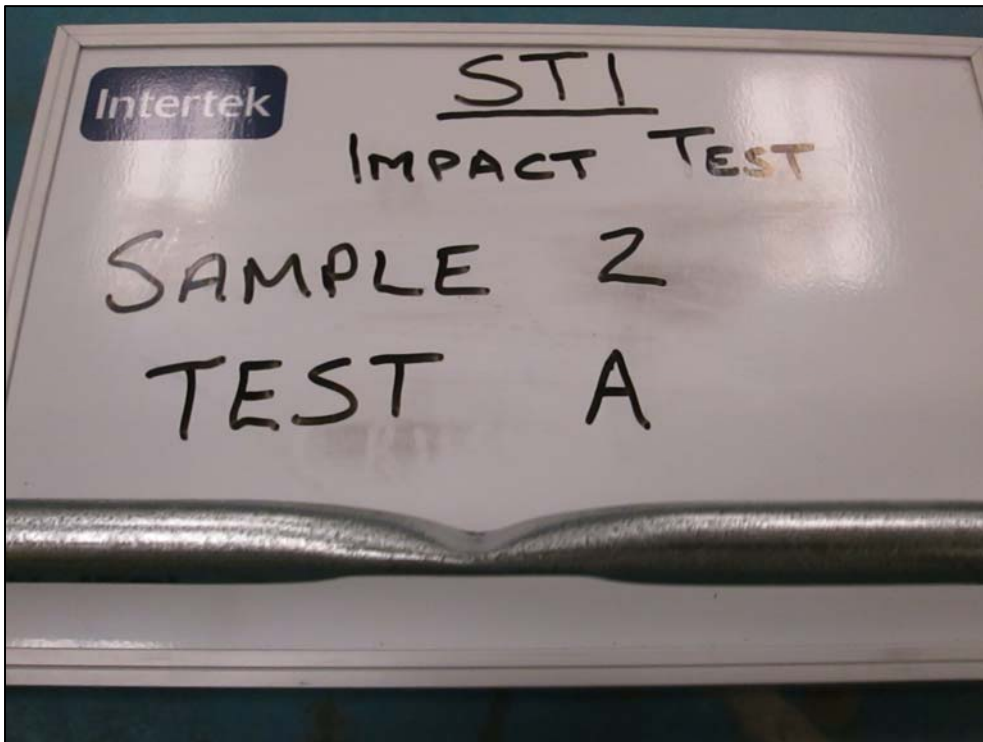
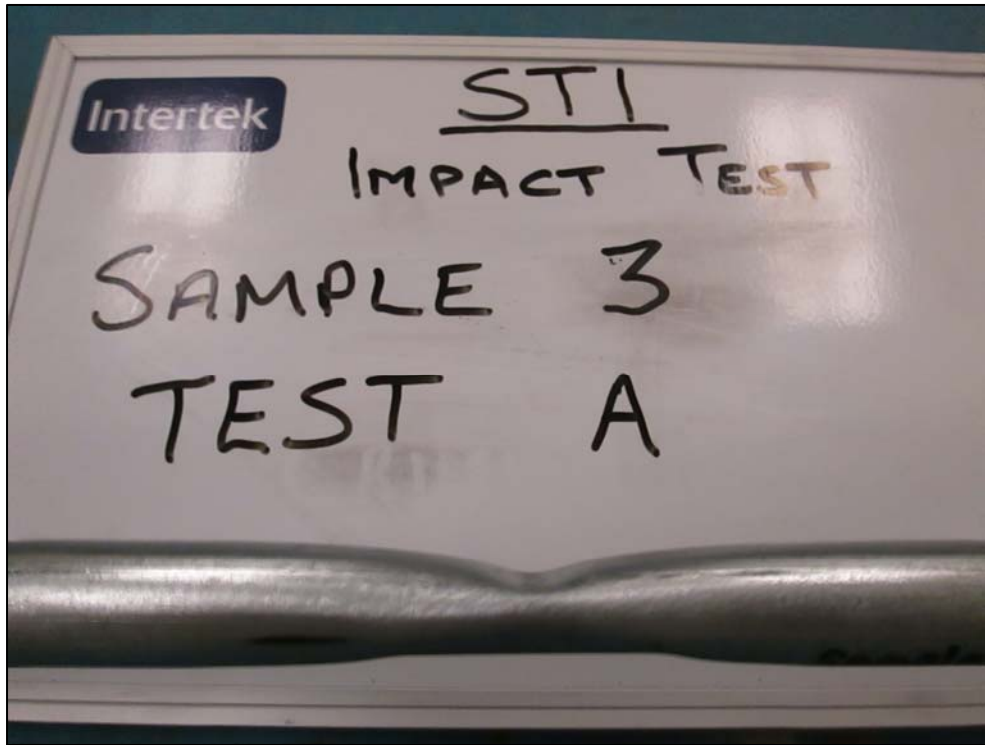
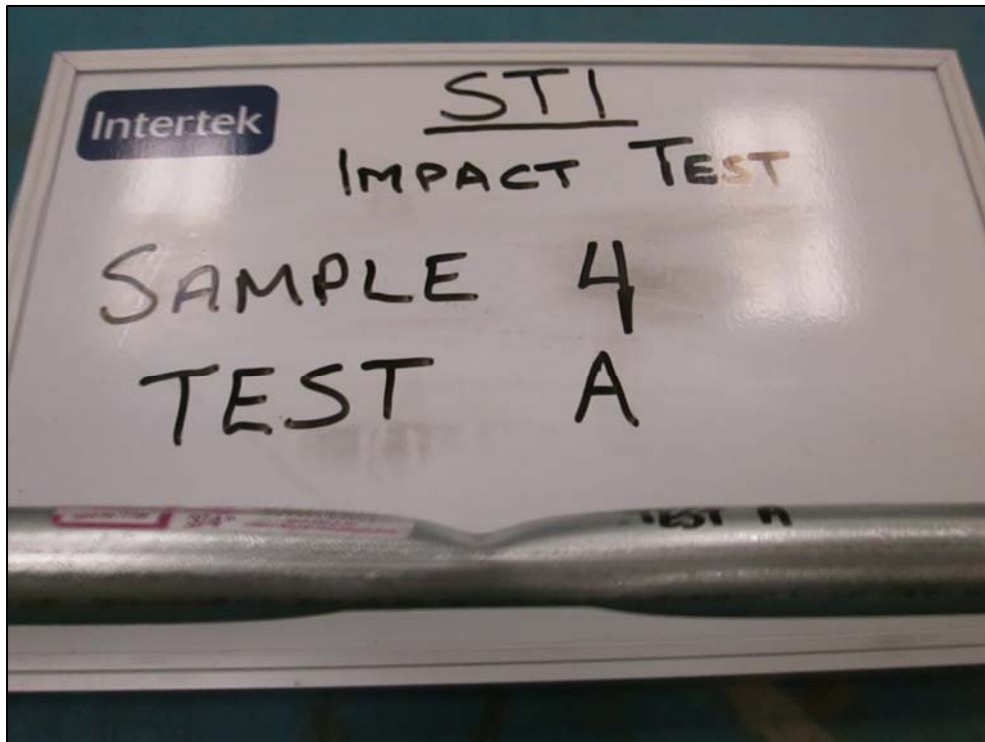
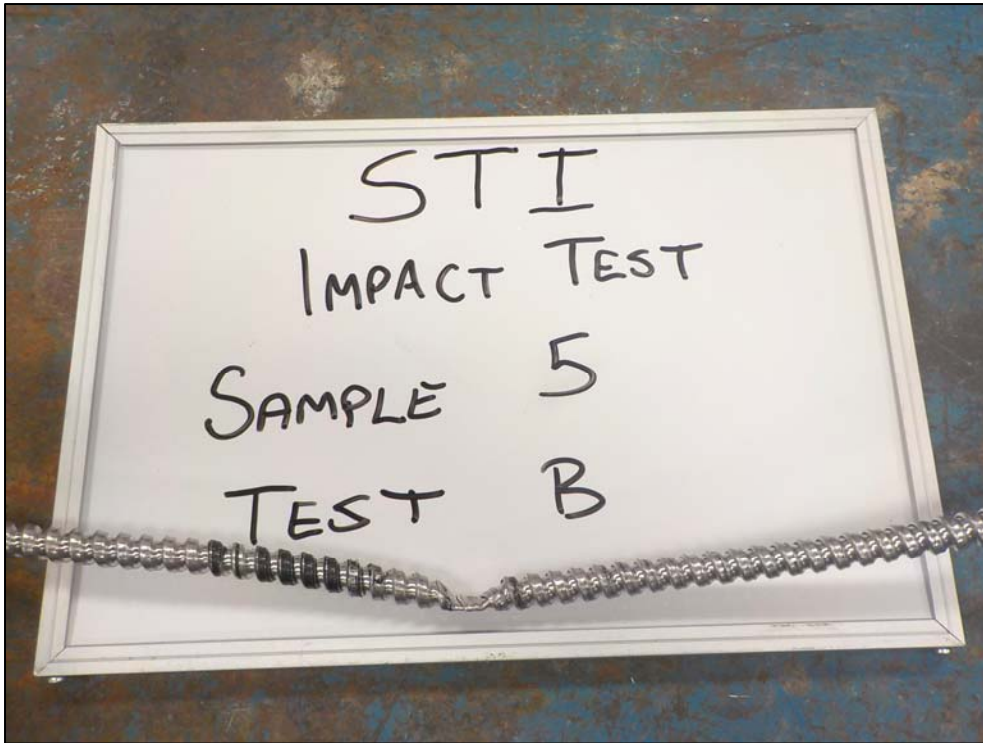
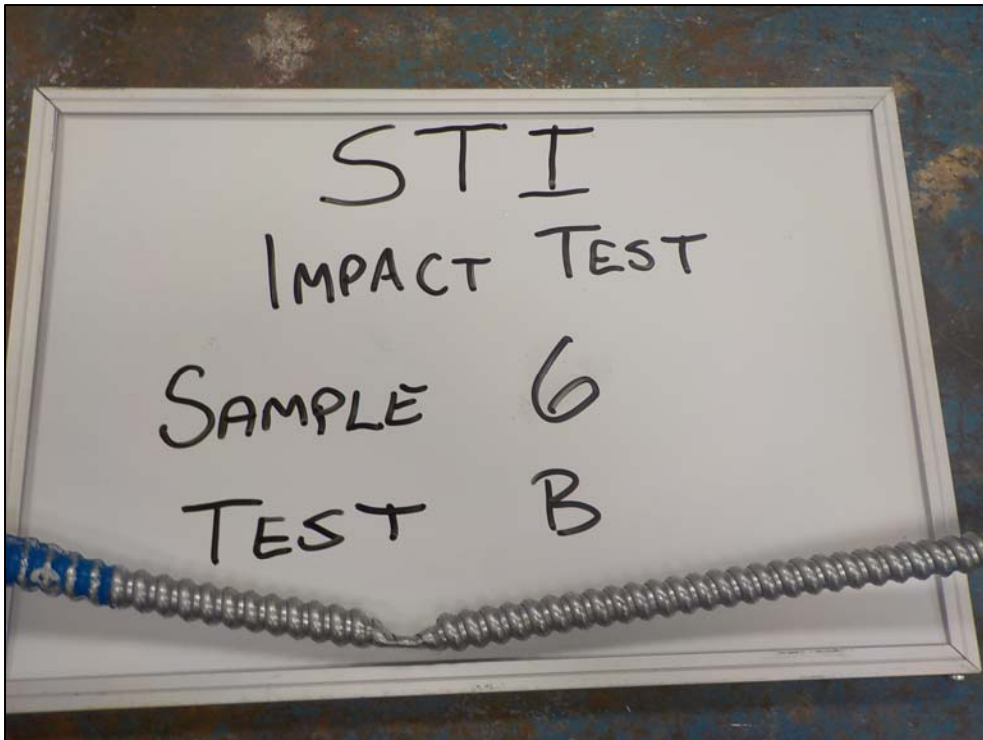
Figure 1. After Impact Test

Figure 2. After Impact Test

Figure 3. After Impact Test

Figure 4. After Impact Test

Figure 5. After Impact Test

Figure 6. After Impact Test

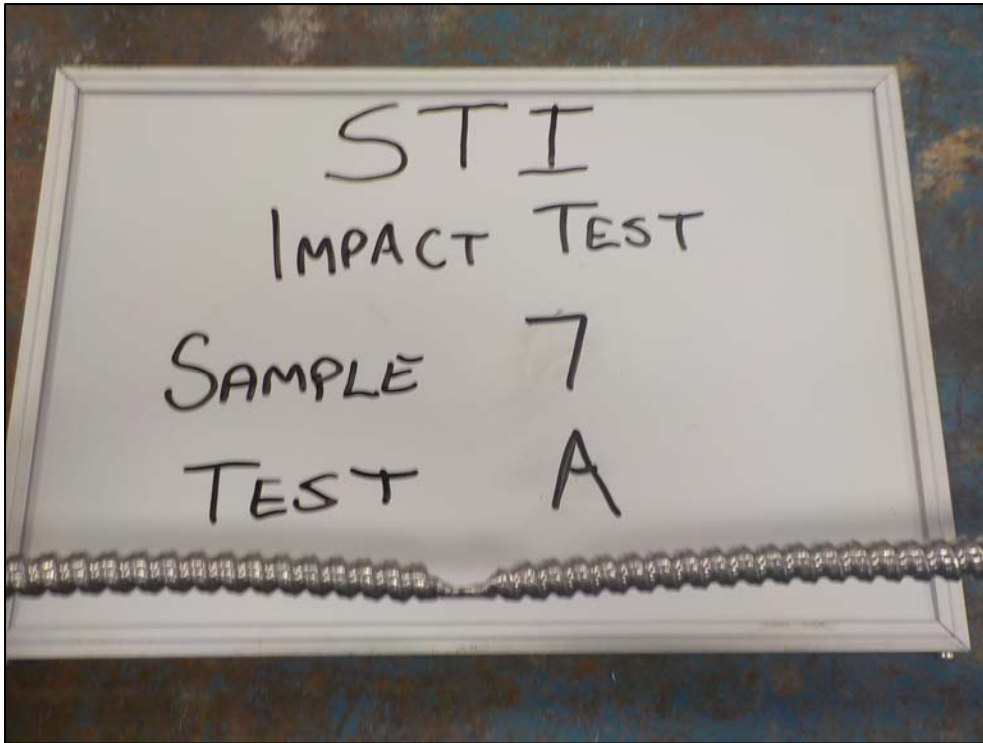
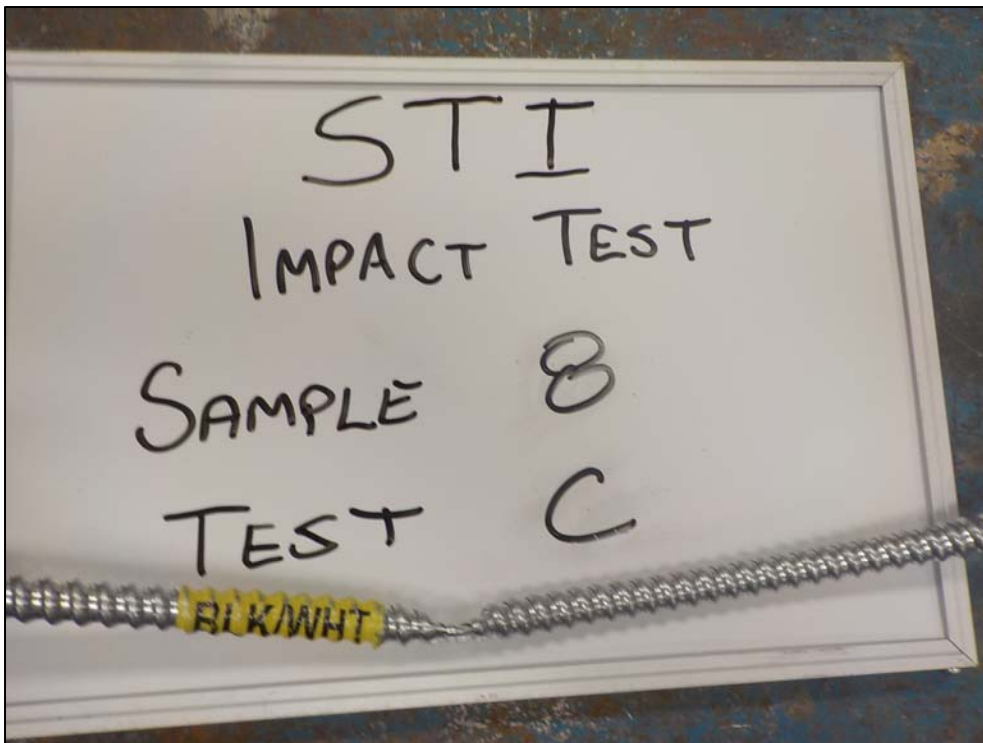
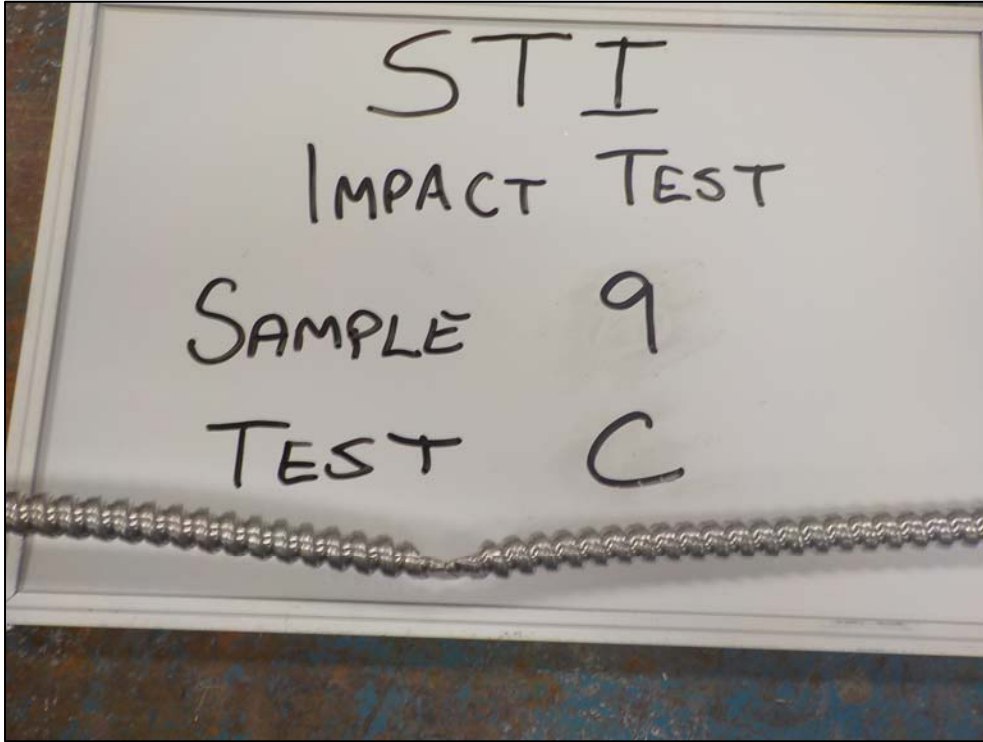
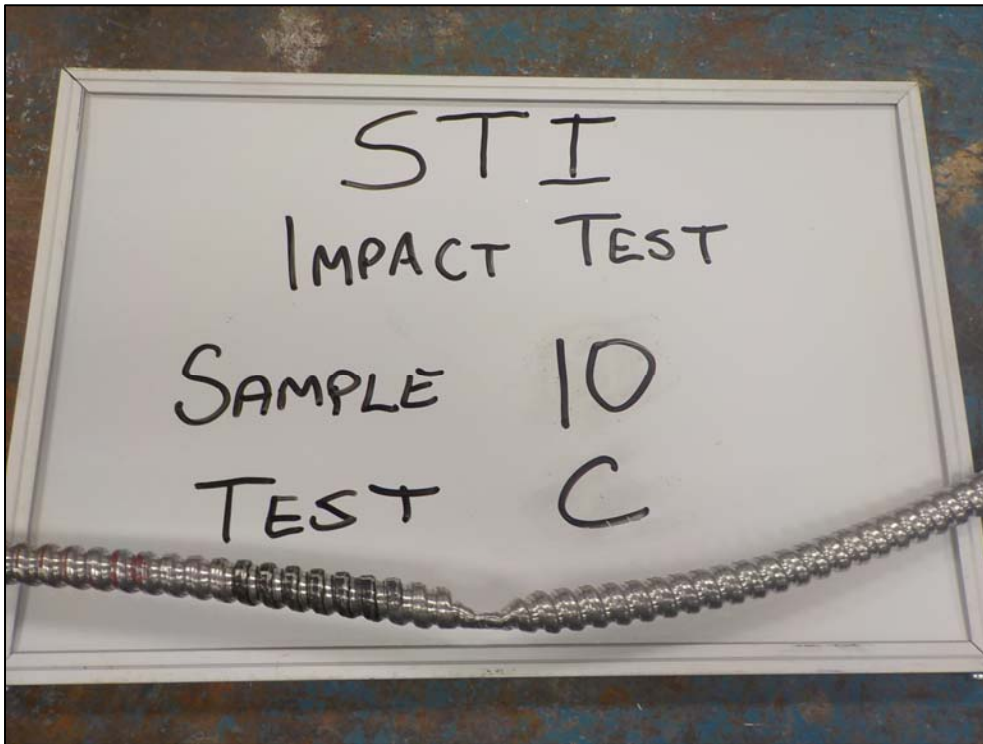
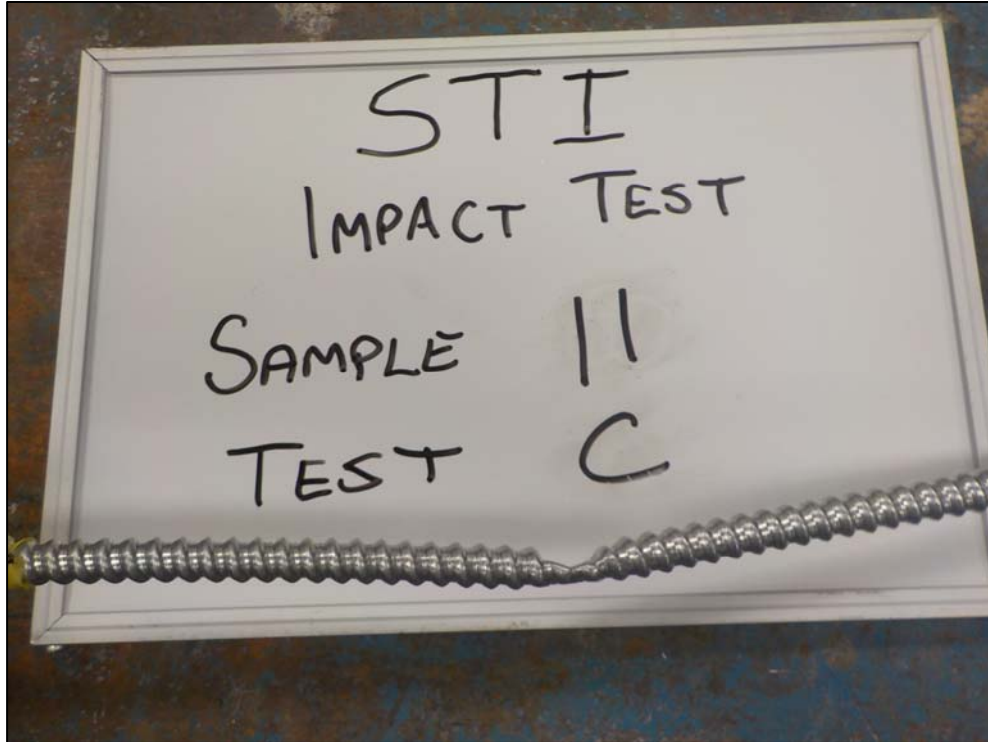
Figure 7. After Impact Test

Figure 8. After Impact Test

Figure 9. After Impact Test

Figure 10. After Impact Test

Figure 11. After Impact Test

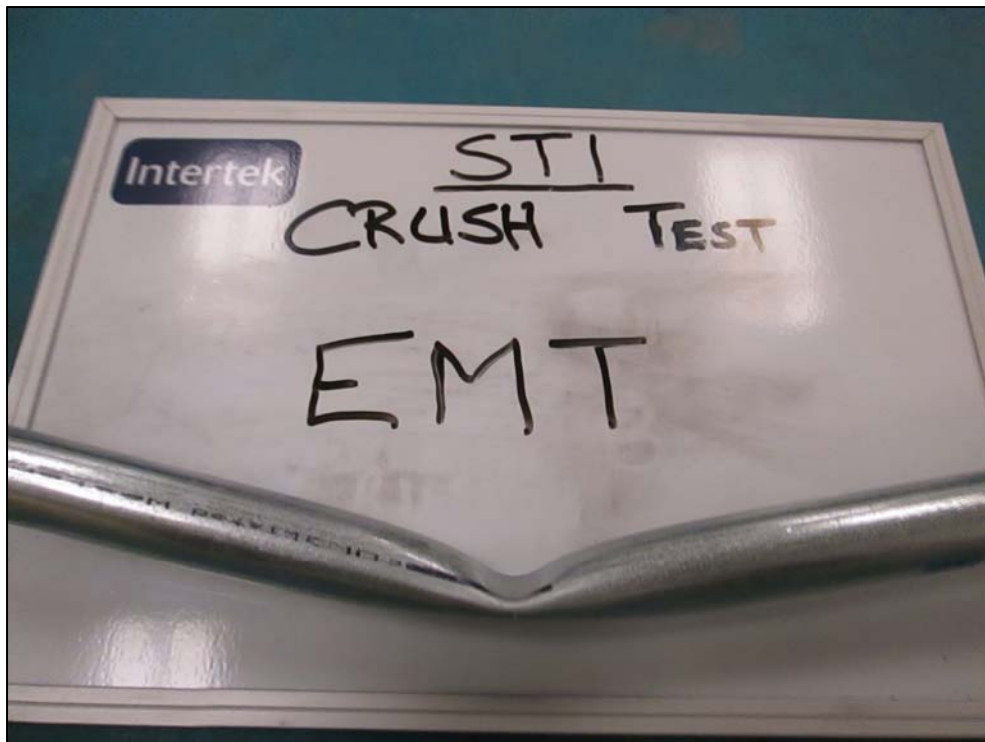
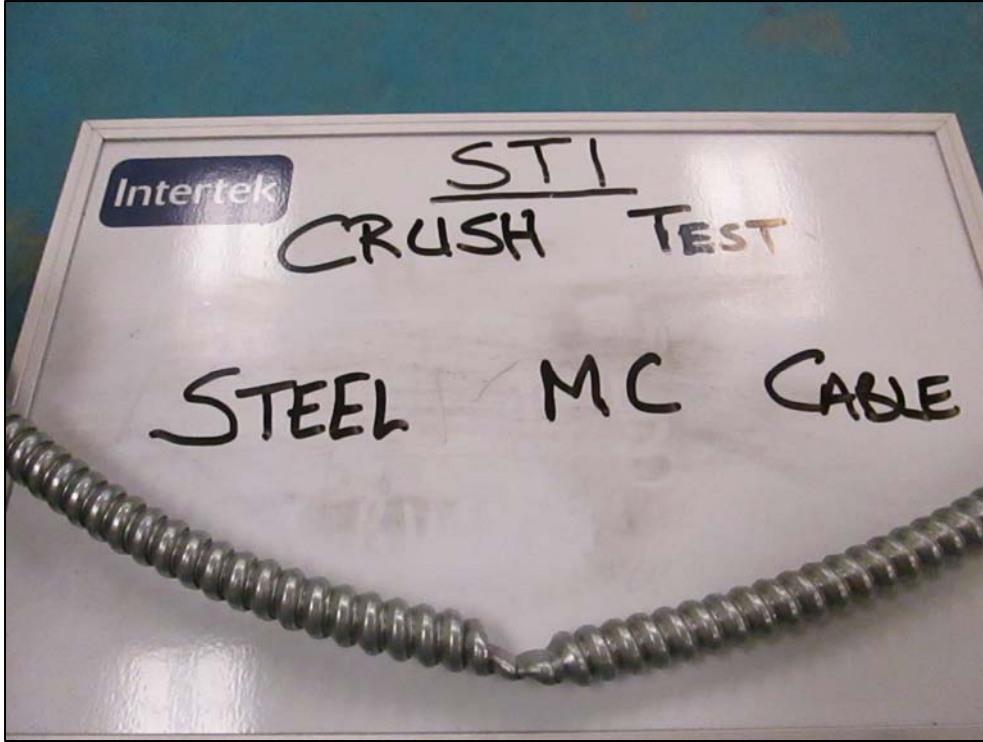
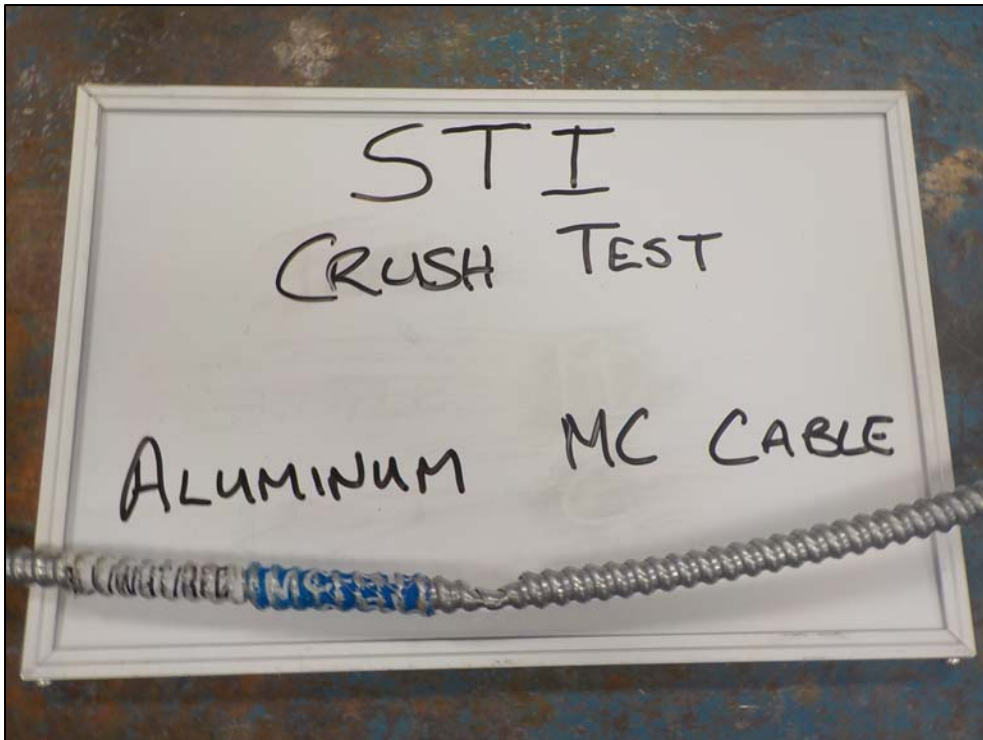
Figure 12. After Crushing Test

Figure 13. After Crushing Test

Figure 14. After Crushing Test

Each sample was tested at a compression rate of 0.50 ± 0.05 in./min until one or more of the indicators signaled that contact occurred between the circuit conductors or between one or more of the circuit conductors and any grounding conductor, the armor, or both. The maximum load obtained at the moment of contact was recorded. The three test results were averaged and reported. Refer to Appendix B for after test photos of the samples.
